*T h e*  
**California Earthquake**  
**of 1906**

*Edited by*  
**David Starr Jordan**

# The Destructive Extent of the California Earthquake. Its Effect Upon Structures and Structural Materials Within the Earthquake Belt

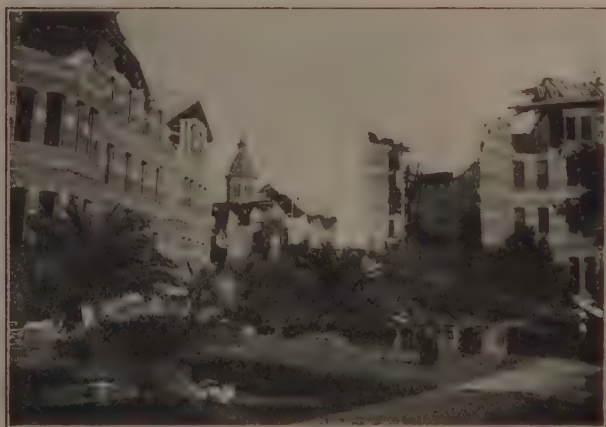
FIG. 44.—View at Agnews Showing the Complete Collapse of the Main Tower of the Asylum.

seriously to realize the situation? The main central brick structure and tower of Agnews Asylum, Fig. 44, entirely collapsed. The central tower fell en masse and crumbled to pieces so that three distinct wings of the buildings, themselves much demolished, were left disconnected. Some of the outer, smaller buildings had nine-inch brick walls

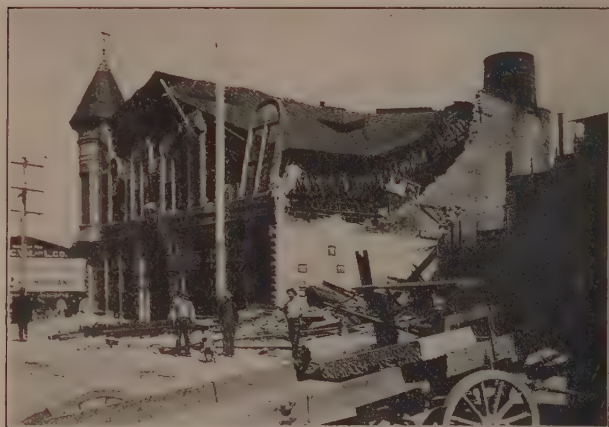
FIG. 45—*Earthquake Destruction, Native Sons' Hall, San José.*

San José, about forty miles to the south and east of San Francisco, is thirteen miles to the east of the fault line. This city fortunately was spared a conflagration. The earthquake destruction was appalling, as is shown by a few typical photographs; see Figs. 45, 46, 47, and 48.

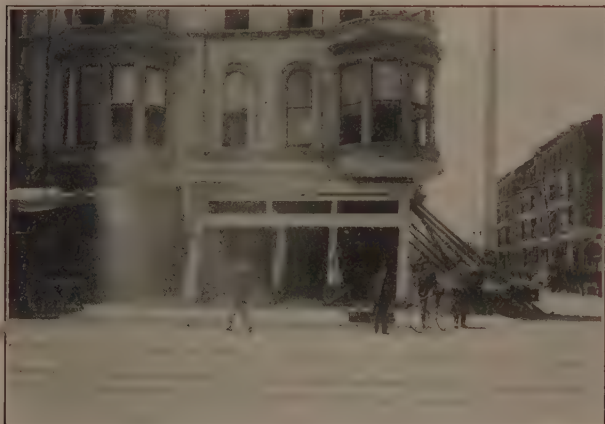
FIG. 46—*A View on First Street, San José, Showing Lack of Framing for First Floor. These Buildings Were Later Pushed Back into Place.*

occupied these main floors, demanding large window openings and as much floor space as possible. Virtually the upper portions of the buildings rested on stilts; see Fig. 46. Public buildings in San José, with the exception of the postoffice, were

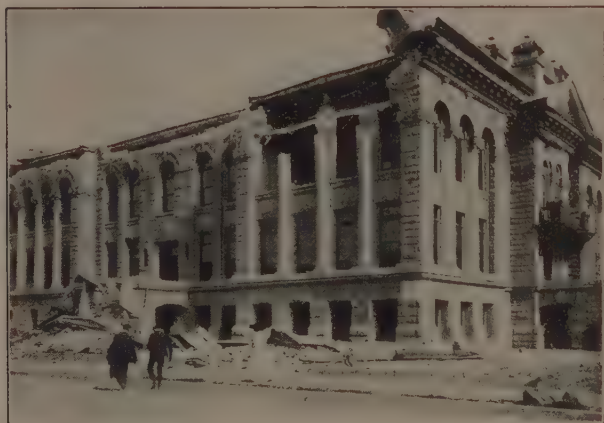
FIG. 47—*Hall of Justice, San José, Completed in 1905.*

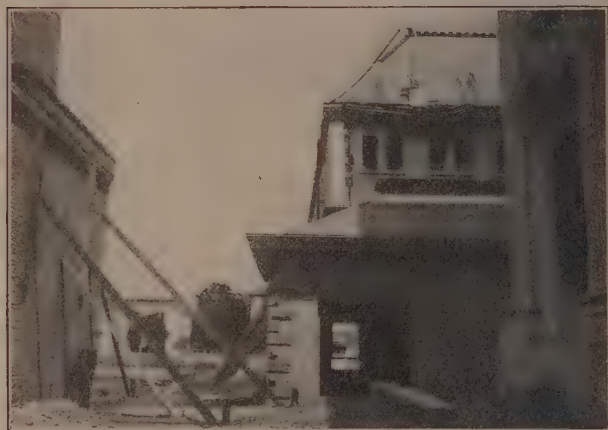
FIG. 48—Rear View, Hall of Records, San José, Showing How the Heavy Stone Outer Walls Cracked Away from the Interior Framing Due to Improper Anchoring of Walls to Floors and Roof.

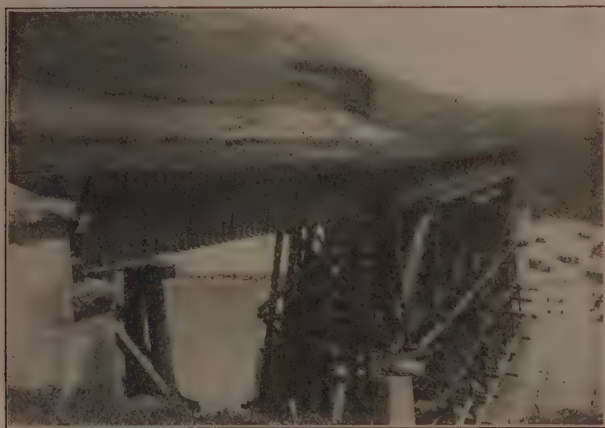
FIG. 49—Pájaro River Bridge, Southern Pacific Railroad; Temporarily Strengthened by Timber Bents and False Work; View Taken May 30, 1906.

It is on a six-degree curve whose chord makes an angle of about  $40^{\circ}$  with the fault line. The fault crosses the bridge near the west end. The bridge consists of two end deck-plate girder spans of fifty feet each, and four intermediate deck Pratt trusses, each of 120-feet span; Fig. 49. The abut-

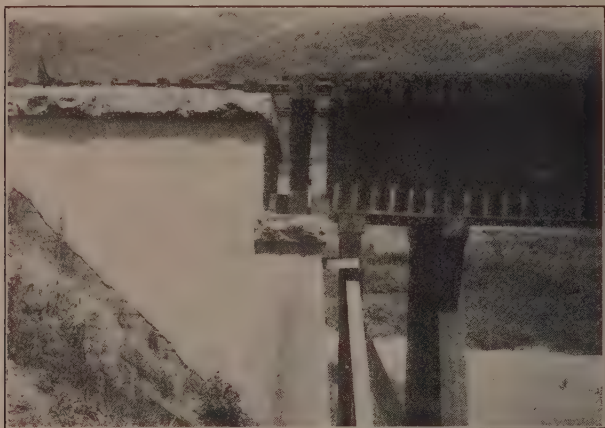
FIG. 50.—*West Abutment, Pájaro River Bridge, Southern Pacific Railroad.*

racking, since the ground upon which its piers rested moved unequally. The distance between the end piers was increased  $3\frac{1}{2}$  feet. All the piers and abutments were moved more or less, but the heaviest movements occurred at the west end of the bridge. Fig. 50 shows the west abutment where the steel plate girders were moved 24 inches off the abutments and had to be supported by a

temporary wooden bent. The plate girder span resting on this abutment did not fall during the earthquake, although it was dragged off the bridge seat, because it was held up by the rail fastenings and the riveted connections to the next span to the

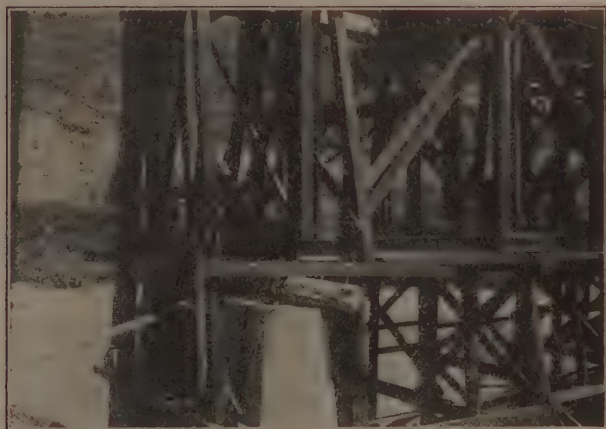
FIG. 51—*First Intermediate Pier, West End, Pájaro River Bridge, Southern Pacific Railroad.*

east. Fig. 51 shows the first intermediate pier at the west end of the bridge. This pier near its base was ruptured in a horizontal section, probably a level between two days' concrete work. The mass of the pier above the rupture was moved eastward about three inches with respect to the base. The coping was ripped from the top and moved

eastward relatively more than 20 inches. The segmental rollers and the steel pedestals upon the coping were smashed and the anchor bolts severely bent. The next intermediate pier leaned somewhat to the east, and the anchor bolts above the coping were bent so that the pedestals of the steel work were moved some three inches. The distortion was less as one approached the eastern end of the structure. The eastern abutment was considerably cracked. The whole bridge superstructure was thrown slightly out of plumb. Earth motions are clearly seen in Fig. 50, where the sloping earth was moved 18 inches along the side wall of the west abutment.

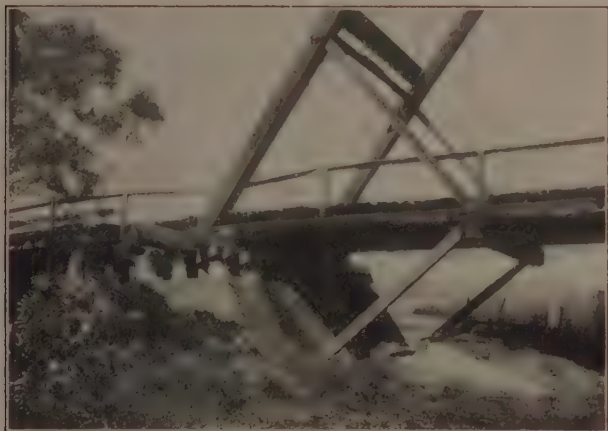
direction a distance of about six feet. Fig. 52 shows the south abutment of the Salinas highway bridge. The ground under the superstructure moved about six feet, careening the pile foundations as shown in the picture, without seriously injuring

FIG. 52—*South Abutment, Salinas Highway Bridge.*

the trusses. A three-inch oil pipe line which crossed the bridge was ruptured on the south approach, one length of pipe being bent to form the letter "S." The northern approach to the bridge was hardly affected. In fact, the northern bank of the river shows little disturbance at this point. From the Salinas bridge eastward, a distance of about  $1\frac{1}{2}$  miles to Spreckels, the south bank of the river is

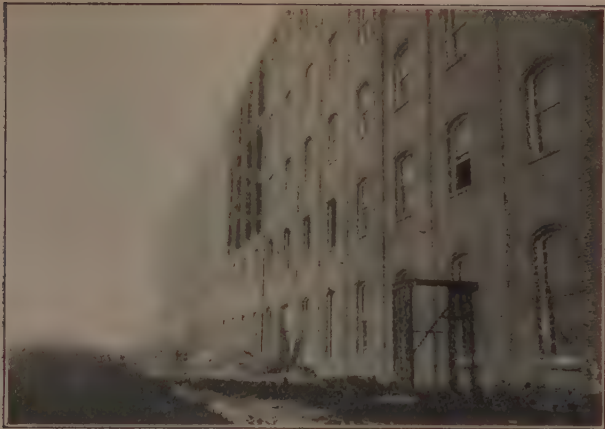
FIG. 53—West Wall, the Spreckels Sugar Mill, near Salinas, Showing Bulged Wall and Brickwork Thrown from the Steel Frame.

The east wall was buckled concave outward, and was badly cracked, but little of it fell. The west wall, in the middle third, was buckled convex outward, and naturally the brick work was thrown down in large masses. Fig. 53 shows the west

wall of the building. I believe this building was subjected to an earth movement from south to north, which accounts in a measure for the buckling of the long walls in the middle unsupported third. There may have been some settling of the walls also. Large masses of brick in the north wall, Fig. 54, were thrown down. Fig. 55 shows a rupture in the carriage way to the dumps at the south

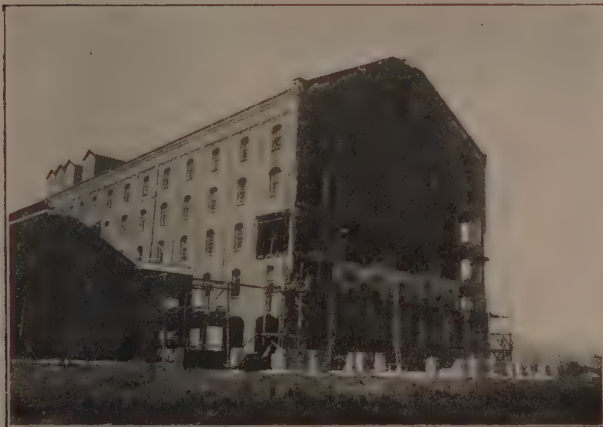
FIG. 54—North Wall, the Spreckels Sugar Mill, near Salinas, Showing Ruptured Brick Curtain Walls and the Advantages of a Class A Steel Frame.

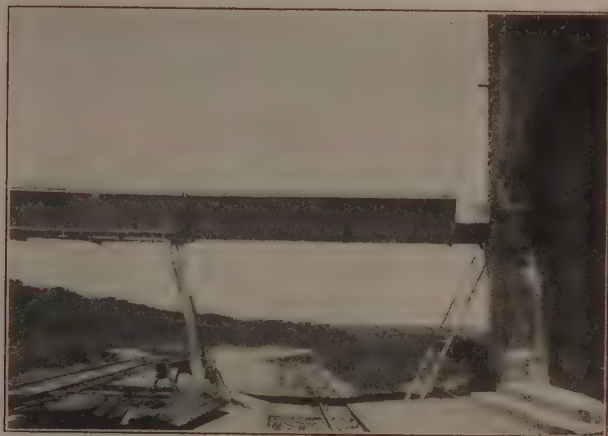
FIG. 55—Ruptured Conveyor, the Spreckels Sugar Mill, near Salinas.  
*Showing Slipping of the Ground into the River.*

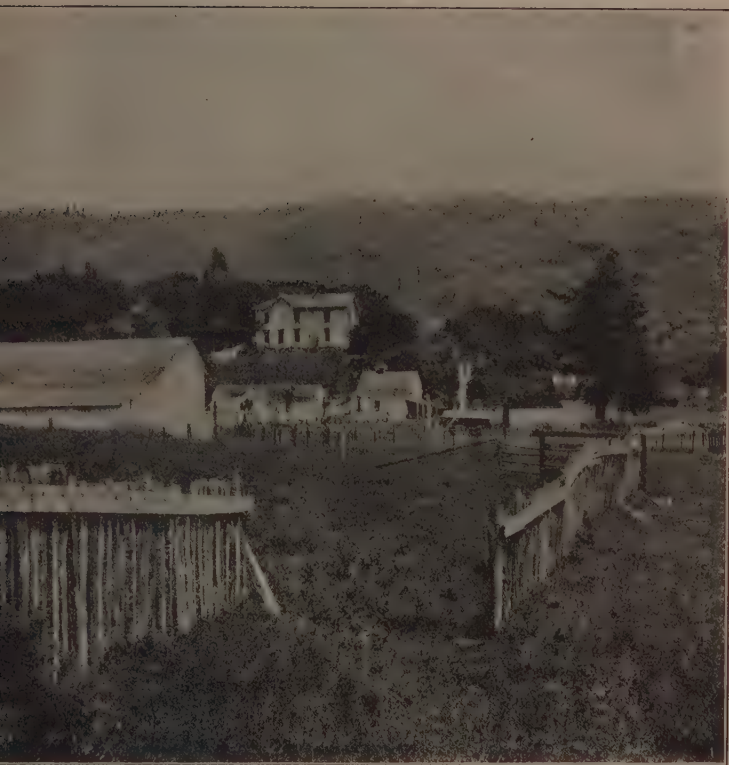
FIG. 3—This Fence, Previously Continuous and Straight, Was Broken and Parted by the Earthquake Fault, the Offset Being  $8\frac{1}{2}$  Feet. The Line of Fault, Concealed by the Grass, Crosses the Ground from Left to Right, Touching Both the Dissevered Ends of the Fence.

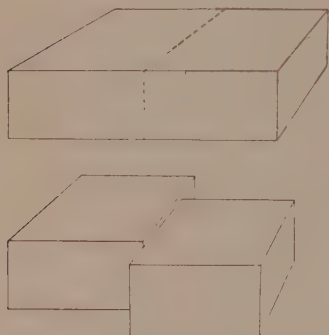
FIG. 4.—*Diagrams Illustrating the Dislocation Causing the California Earthquake. The Upper Represents an Earth Block 100 Feet Square and 25 Feet Thick, with Indication of the Position of the Fracture. The Lower Shows the Relation of Its Two Parts after Faulting.*

That which occurred along this line was a differential movement and permanent displacement of the rock and earth on the two sides of a vertical crack. The principal displacement was not vertical, but horizontal. If one thinks of the land to the east of the crack as stationary, then the change may be described as a northward movement of the land west of the crack. If the land to the west be thought of as stationary then the land to the eastward moved toward the south. It is probable that both tracts shared in the movement, the eastern shifting toward the south and the western toward the north. Perhaps the nature of the change can be more readily understood by reference to Fig. 4, which represents an ideal block of the earth's crust, 100 feet square on the surface and 25 feet deep, before and after its division and dislocation by the earthquake-causing fault.

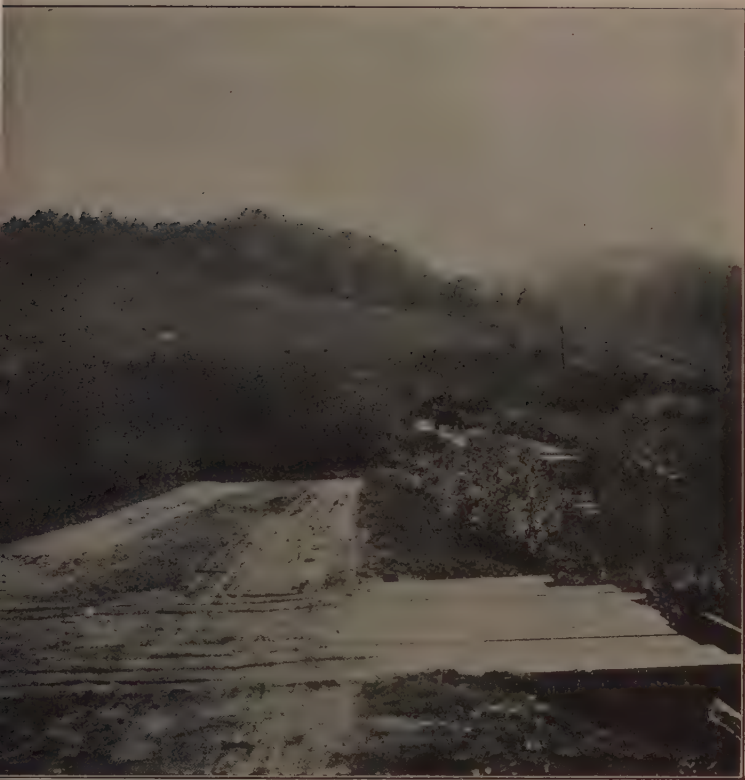
FIG. 5—A Faulted Road near the Head of Tomales Bay. The Nearer and More Distant Parts of the Road Were Originally in One Line—a Continuous, Straight Road. The Present Offset is Twenty Feet.

of about 10 feet. At one place (Fig. 5) a road was offset 20 feet, but in this case the underlying ground was wet alluvium and part of its movement may have been due to a flowing of the soft material. There was also some vertical change, but this was not everywhere in the same direction and its amount was comparatively small. At many points the land west of the fault appears to have risen one or two feet as compared with the land at the east.

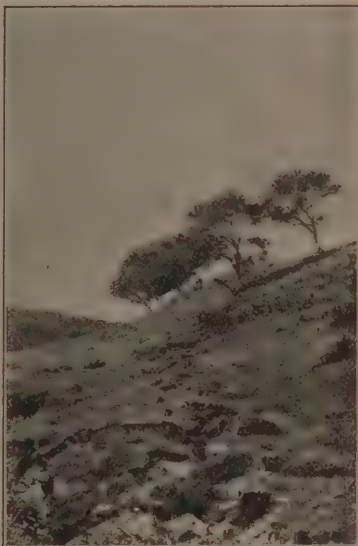
FIG. 6—*Ordinary Appearance of the Earthquake Rift Where It Traverses Firm Turf.*

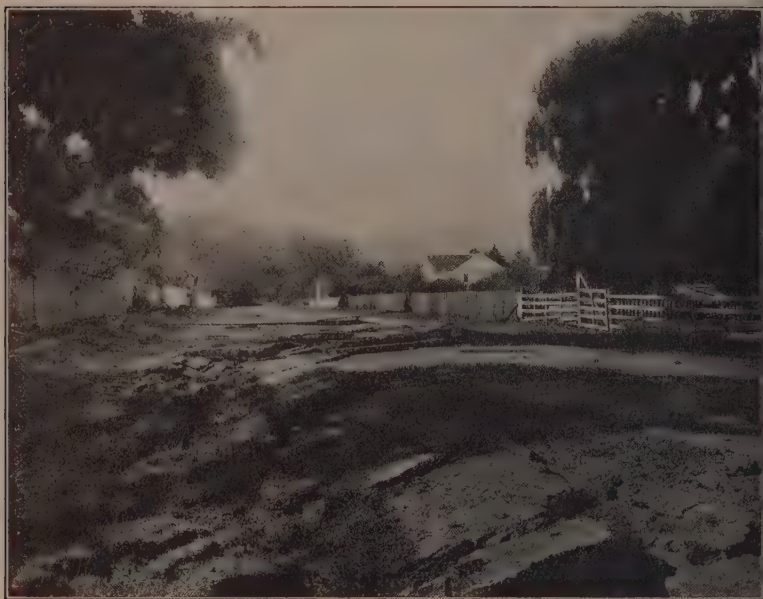
FIG. 7—*A Zone of Earthquake Fracture Where It Crosses a Road Near Bolinas.*

angles and gradually dying out in the adjacent country, and in some of these the belt of disturbance is broad and complicated (Fig. 7). There are also outlying cracks occurring within a mile or two of the central rift and having irregular courses, and these may probably be referred to the same general system of rock strains.

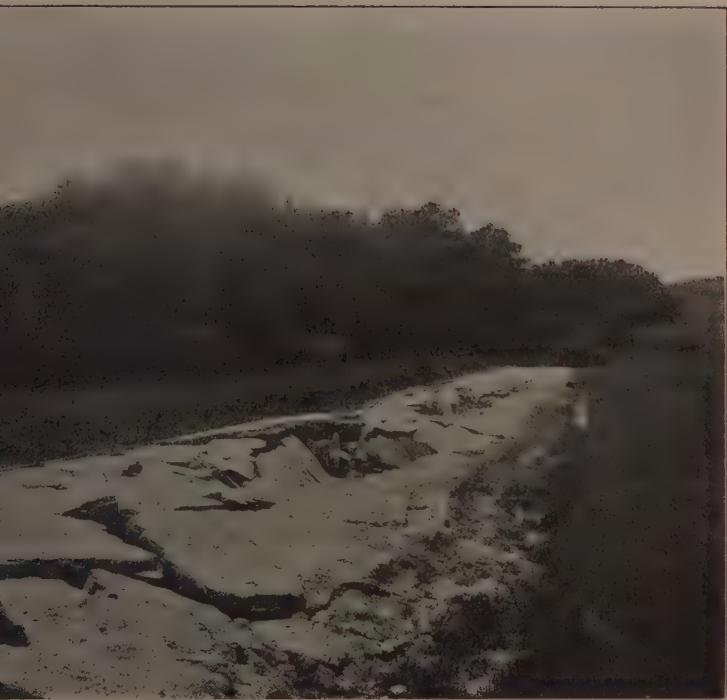
FIG. 8—Cracks Caused by the Shaking of Marshy Ground. The Comparatively Firm Road Embankment Preserved the Cracks Better than the Bog.

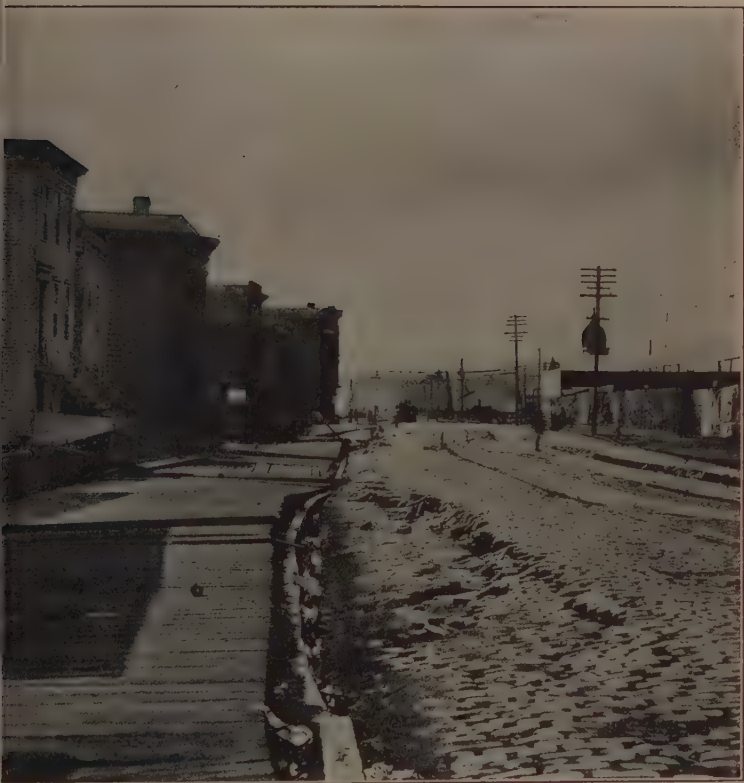
FIG. 9.—Street Scene in San Francisco, Showing Effect of the Earthquake on Filled Ground.—The Distant Part of the Street Probably Retains Its Original Level and Position. Nearer by the Ground Has Settled Several Feet and Has Also Moved to the Left.

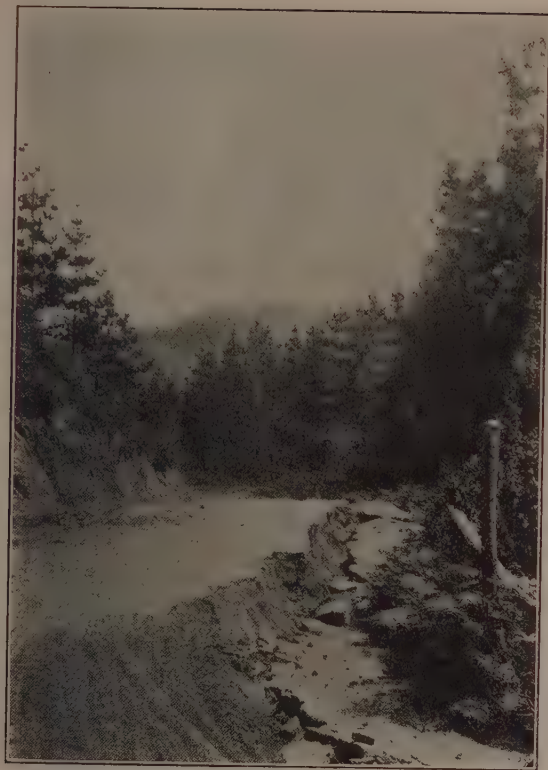
FIG. 10—Road Crack Caused by the Earthquake.

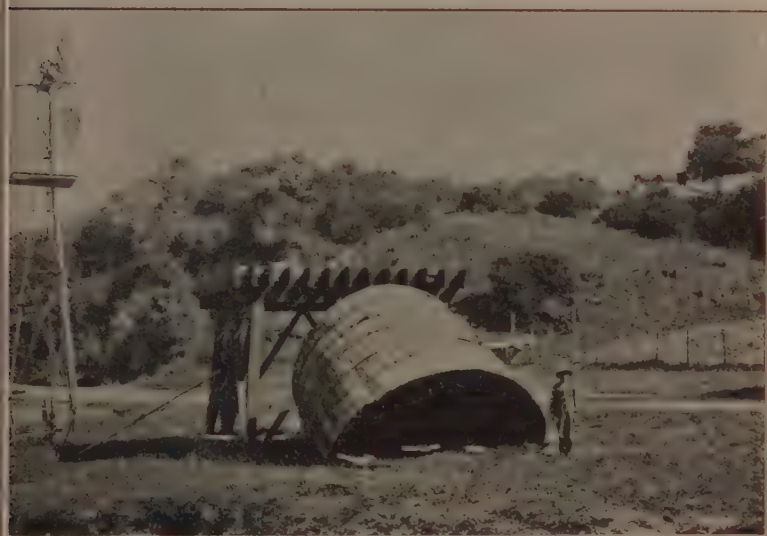
*FIG. 12—Water Tank Thrown from Its Pedestal by the Earthquake.*

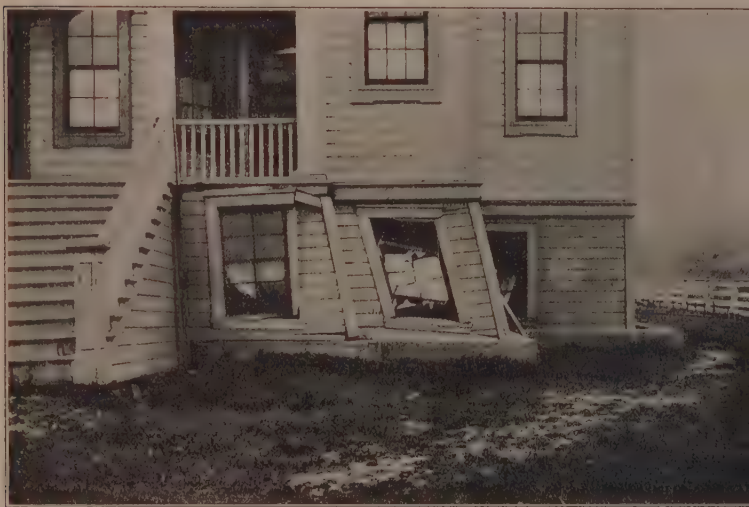
FIG. 13—School-House at Point Reyes Station, Near Inverness; Shifted Horizontally Two and One-Half Feet by the Earthquake. The Corner Here Shown Was Slipped from the Foundation and Rests Directly on the Ground.

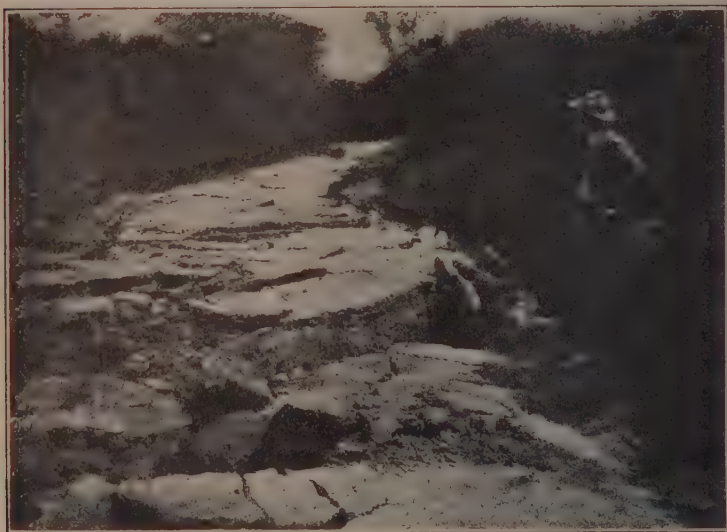
FIG. 3.—Road Crossing the Fault Line Two Miles Southeast of Portolá. There Is a Vertical Uplift on the Northeast Side of the Fracture at This Place.

northeast, or a small downthrow on the southwest, or both. The lateral displacement is well defined, as far as it has been traced, and at some points amounts to as much as 9 feet. The vertical displacement in most places is not so evident, but about a mile southeast of Portolá there is an uplift

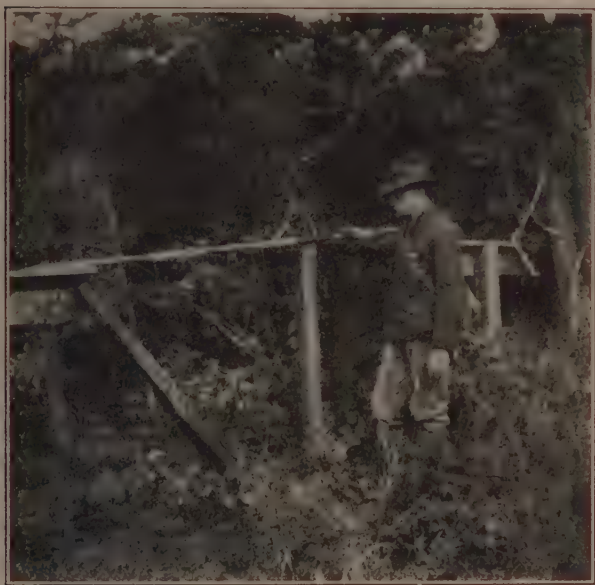
FIG. 4—Showing a Fence That Crossed the Fault at an Oblique Angle. The Post Shown in the Photograph Was Split and Pulled Apart and the Wires Broken.

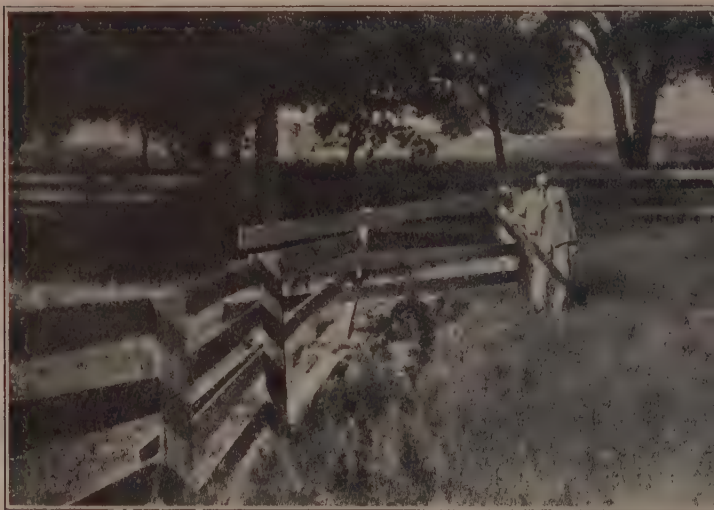
FIG. 5.—Showing a Fence That Was Broken and Offset Eight Feet Where It Crossed the Fracture.

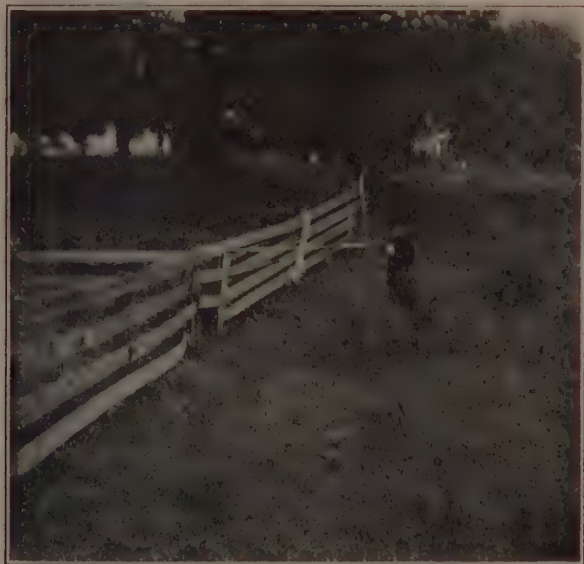
FIG. 6—*Photograph of a Fence Crossing the Fault-Line at Right Angles. The Man is Holding an Eight-Foot Transit Rod and Stands in Line with Continuation of the Fence on the Far Side of the Fracture. The Fence Was Repaired Before the Photograph Was Taken.*

The photograph (Fig. 6) shows a line fence crossing the fault a mile southeast of Woodside. This fence was broken and displaced over 8 feet, but had been repaired before the photograph was taken. The man at the right in the picture is holding an 8-foot transit rod, and he is standing in line with the continuation of the fence on the far side of the fracture. The crack crosses the fence just back of where he is standing.

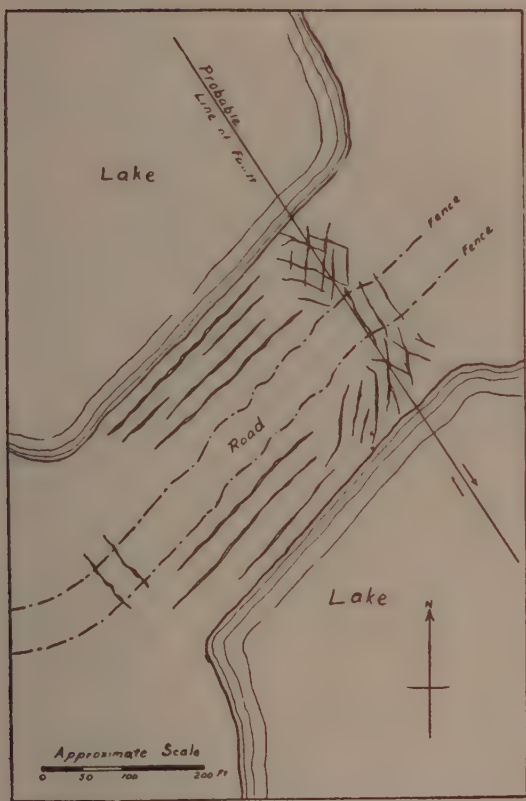
FIG. 7—Dam at Crystal Springs Lake, Showing Cracks Formed by the Displacement.

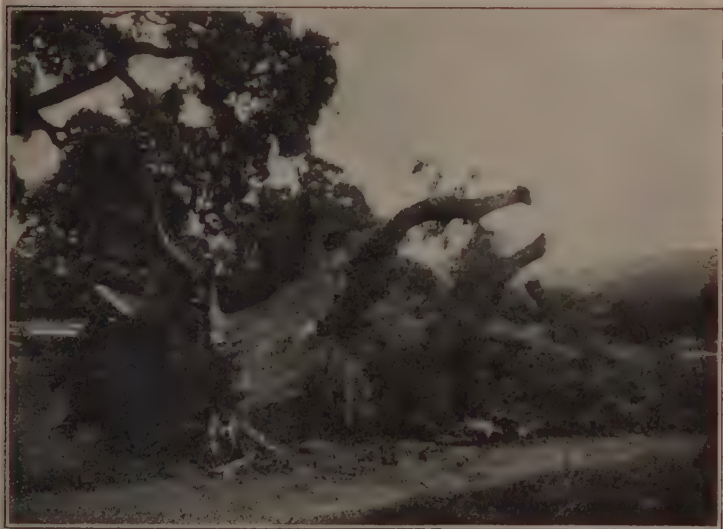
*FIG. 8.—An Oak Tree Six Feet in Diameter Uprooted by the Earthquake Three Hundred Yards from the Fault Line.*

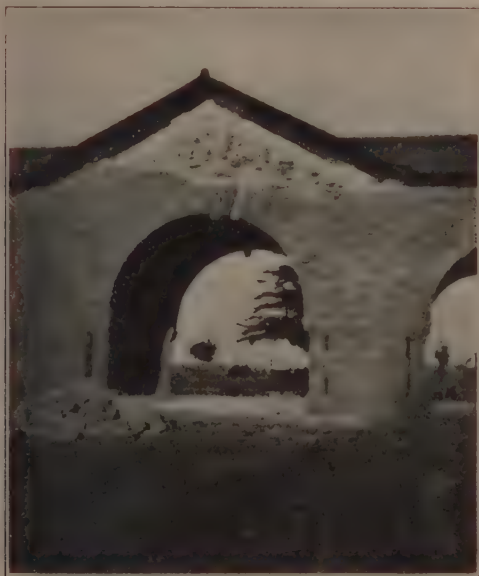
*FIG. 9—Photograph of Arches at Stanford University, Showing Keystones Lowered During the Earthquake. These Arches Were Nearly at Right Angles to the Fault-Line.*

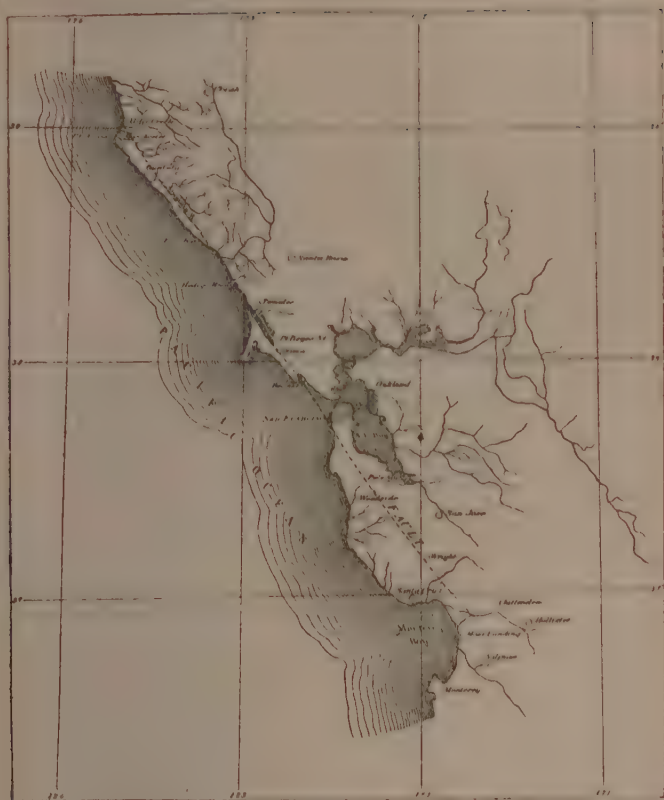
PL. I.

Fig. 1. San Francisco and the Vicinity, Showing the Course of the Great Fault, from Pt. Arena to Chittenden.

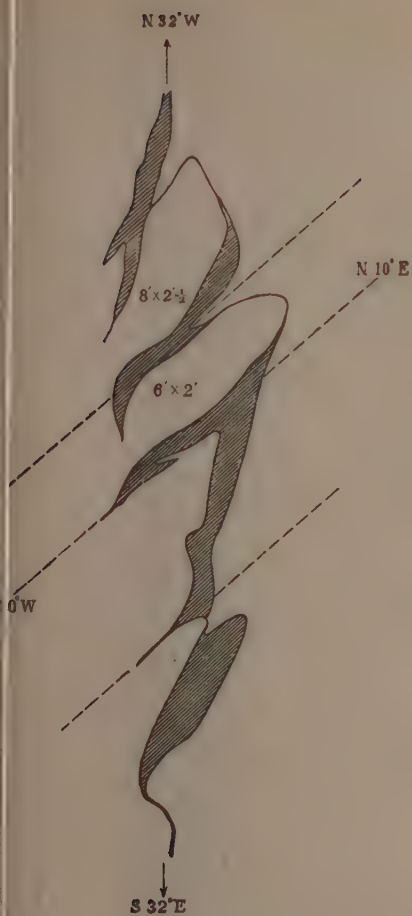
Figs. 8, 9 and 10 show parts of the fault lines found near the town of Manchester, not far from Pt. Arena; the dotted lines in each figure indicating the directions of the secondary shear cracks. Fig. 8 is the plan of the remarkable disturbances shown in Fig. 13. In Figs. 9 and 10, the angle between the main fault line and

FIG. 8—The Shaded Parts Indicate Cracks of the Ground.

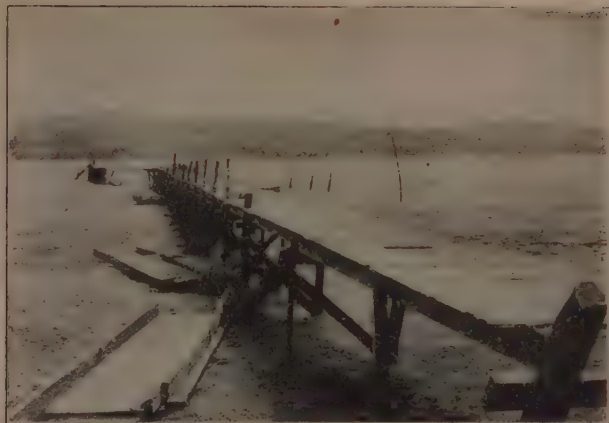
Fig. 11 (Pl. III) shows the shearing effects on a pier at Inverness, on the west coast of the Tomales Bay. The end part of the pier was separated from the rest and was displaced about 20 feet toward NNW. The direction of displacement in this particular instance was opposite to the general direction of the relative slip along the great fault line.

FIG. 11—The Shearing Effects on a Pier at Inverness, on the West Coast of the Tomales Bay. The End Part of the Pier Was Displaced About 20 Feet Towards NNW.

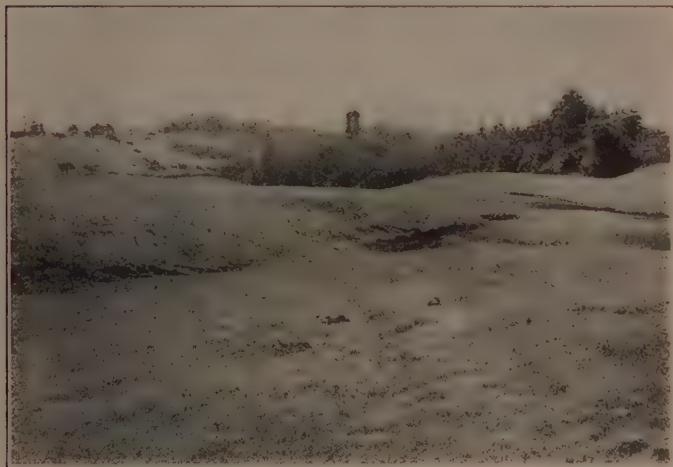
Fig. 12 (Pl. III) shows one of the fault cracks produced among the hills above Fort Ross. It will be observed that the new disturbances appeared along a depression marked by a series of small ponds (shown at the right-hand side of the cut),

FIG. 12—One of the Fault Cracks Produced Among the Hills Above Fort Ross. The New Disturbances Appeared Along a Depression Marked by a Series of Small Ponds (Shown at the Right-Hand Side of the Picture), Which Are Traces Left by a Former Earthquake.

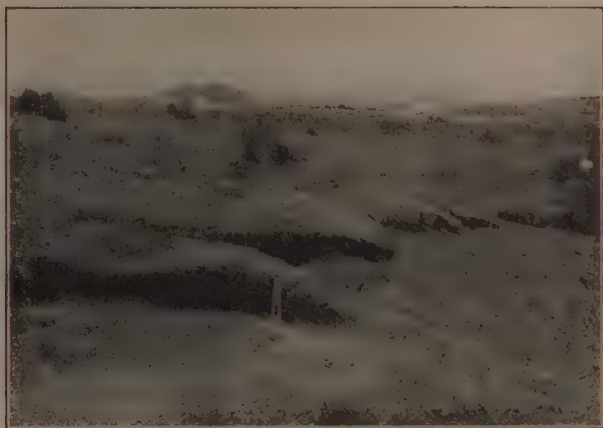
Fig. 13 shows the remarkable compression and shear effects along one of the parallel fault cracks, observed on elevated grounds near the town of Manchester, not far from Pt. Arena. A foot-scale placed in the foreground will show the size of the overlapping earth pieces, whose plan is given in Fig. 8.

FIG. 13—Remarkable Compression and Shear Effects Along One of the Fault Cracks, Produced on Elevated Grounds Near Pt. Arena. A Foot-Scale Placed in the Foreground Shows the Size of the Overlapping Earth Pieces, Whose Plan Is Given in Fig. 8.

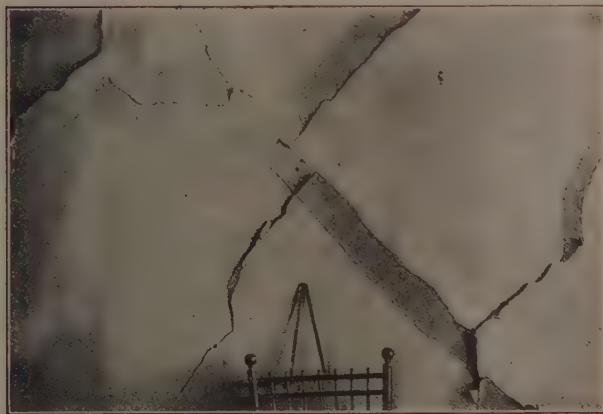
Fig. 14 (Pl. IV) illustrates some of the cracks of plastered walls observed in St. James Hotel, San José.

FIG. 14—Some of the Cracks of Plastered Walls, in St. James Hotel, San José.

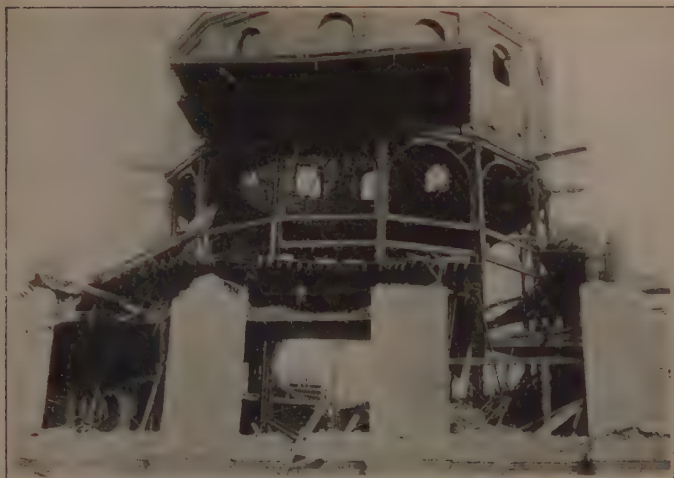
FIG. 15—The Damaged Condition of the Newly Erected Library of the Stanford University. The Central Steel Dome Behaved as an Elastic Inverted Pendulum.

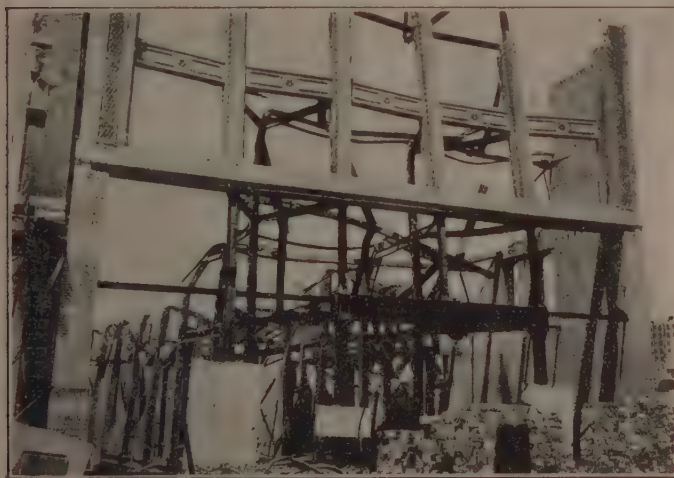
FIG. 16—The Ruined Condition of a Steel-Framed Brick House in San Francisco, Which Was Dynamited and Then Burnt, Showing the Remarkable Effects of the Intense Heat.

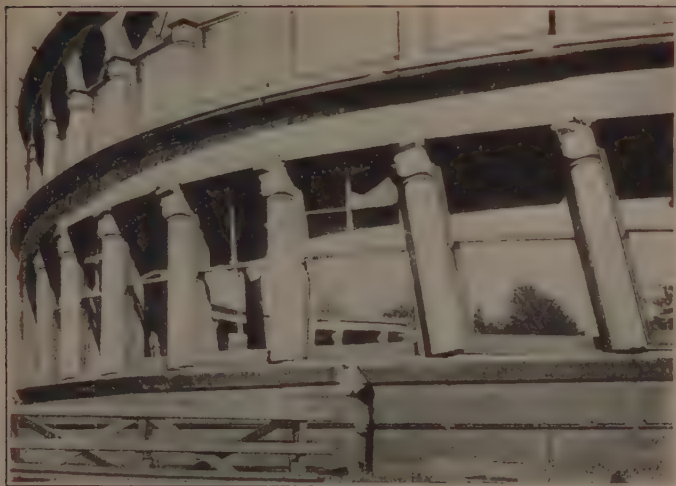
Fig. 17 (Pl. VI) gives an outside view of the back part of the Observatory on the top of Strawberry Hill, in the Golden Gate Park, San Francisco. This building is of reinforced concrete and furnishes a good demonstration of the strength of such structures. The Observatory was indeed seriously damaged and its front portion fell down to the ground, but this was on account of the weakness of the foundation ground, which was mostly a filled-up one and was considerably cracked and depressed. Fig. 18 shows, in a larger scale, one of the cracks of the basement wall, similar to that shown in Fig. 17. The steel cable, one inch in diameter, which was embedded in the concrete, was broken. The use of steel cables in concrete walls thus seems to be objectionable, as they are more liable to rusting than solid steel bars. None of the latter used in the concrete walls and floor of the Observatory, whose section was half inch square, was found broken; the adhesion of concrete and steel being also very good.

FIG. 17—The Observatory on the Top of the Strawberry Hill, in the Golden Gate Park, San Francisco, Built of Reinforced Concrete. An Outside View of the Back Part.

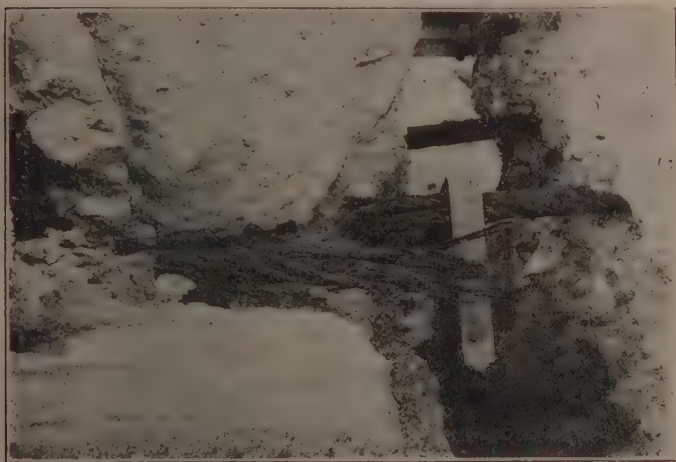
FIG. 18—One of the Cracks of the Basement Wall. The Steel Cable, One Inch in Diameter, Which Was Embedded in the Concrete, Was Broken.

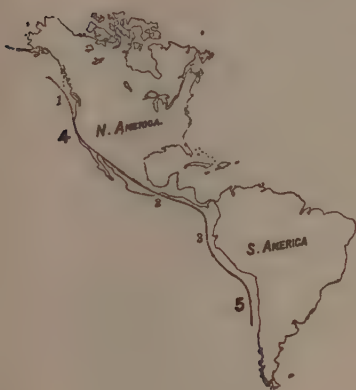
Fig. 20.

approximate positions of these three groups of earthquakes are marked in Fig. 20 by dotted lines, 1, 2, and 3.

which took place on August 17, 1906, is indicated in Fig. 20 by a thick line marked 5.

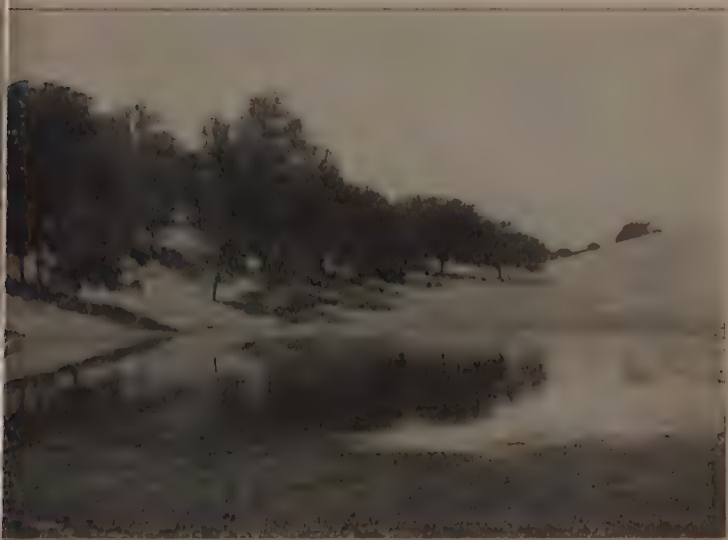
*Lake in a Sunken Area on the Rift in Cholame Valley.*

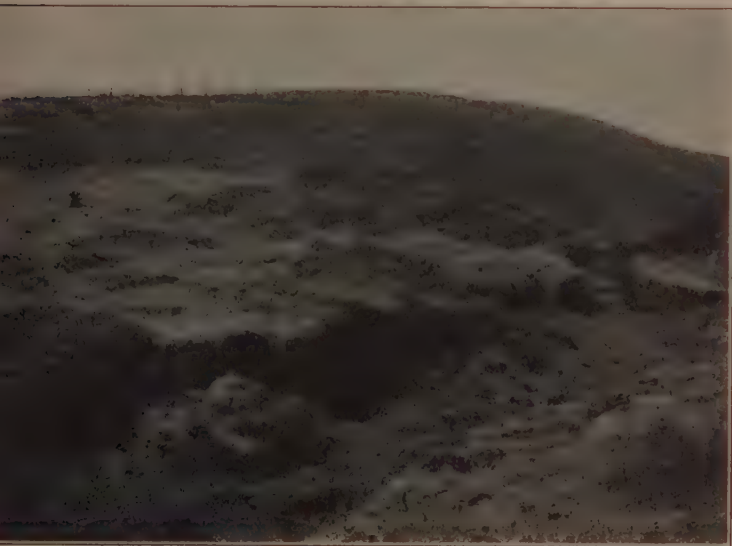
*Effect of Recent Earthquake in the Ridge Above Mussel Rock.*

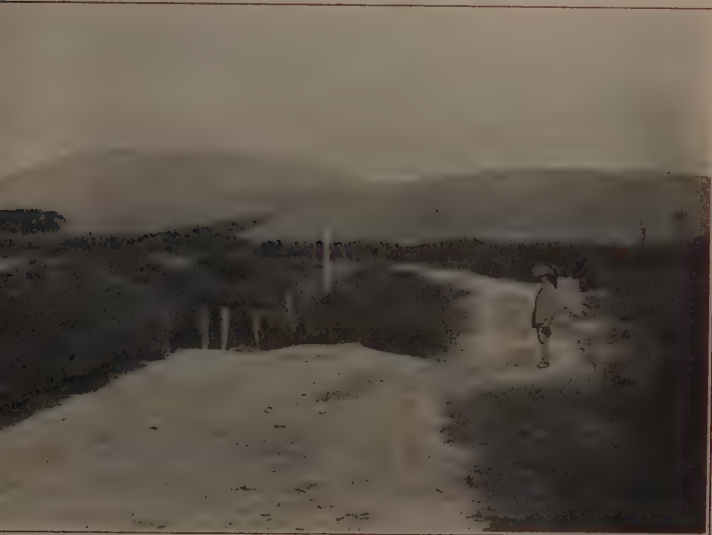
*Road Displaced 12 Feet on Line of Rift at Head of Tomales Bay.*

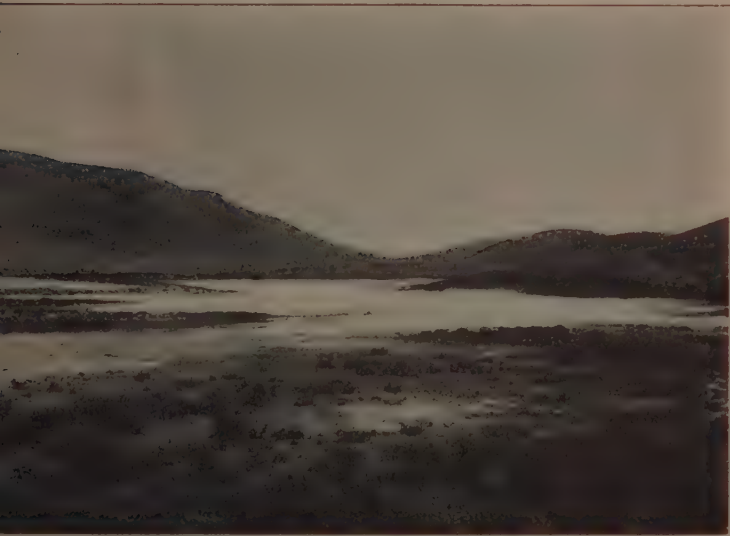
*Alkali Sink on Line of the Rift North of Bakersfield.*

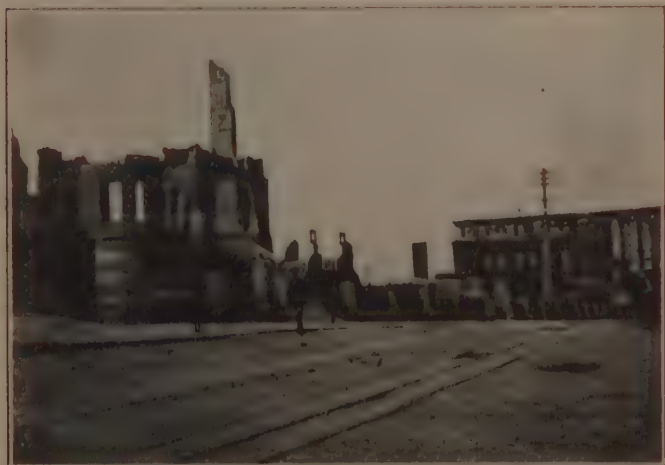
*"Nob Hill" After the Fire, Showing the Huntington, Crocker, and Flood Residences. Fairmont Hotel in Background.*

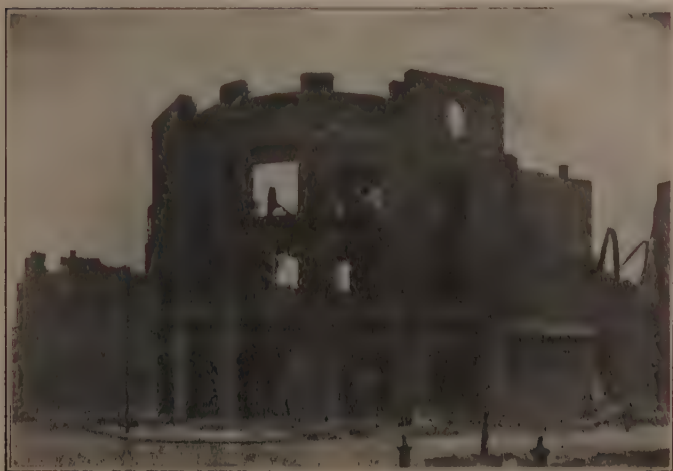
*Tivoli Theatre*

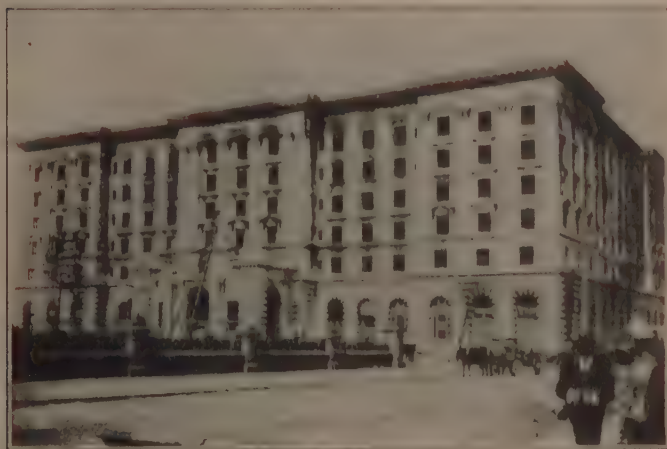
*Fairmont Hotel After the Fire*
